Report No. FAA-RD-72-25

SONIC BOOM AND NATURAL DETERIORATION EFFECTS ON BUILDINGS: WHITE SANDS, N.M. STRUCTURE RESURVEY

J.H. WIGGINS, JR.

(A SUPPLEMENT REPORT TO REPORTS SST 65-15 (VOLS.
1 AND 2) AND SST 65-18)

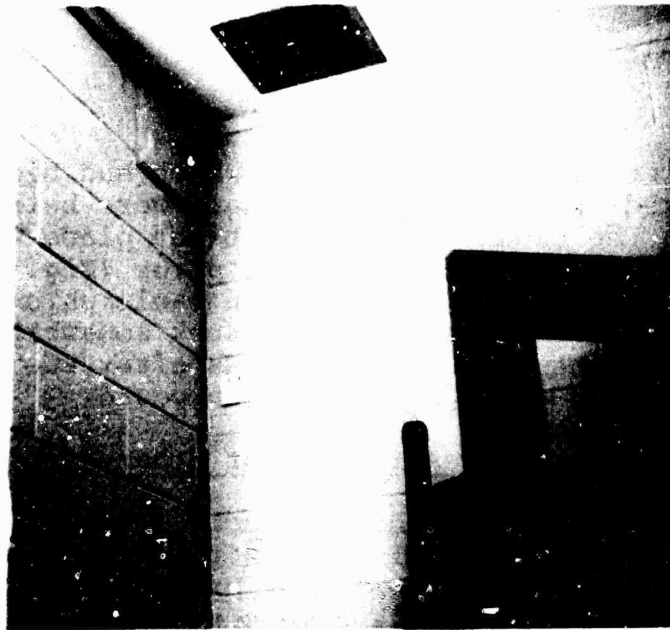
Mr. Bradley noted to me that the ORC Station had been completely redecorated, painted and all cracks caulked about 6 months prior to Feb. 24, 1972. Yet this concrete block building showed new cracks which had been photographed in the chief's office (Fig. 1) and new cracks in the power room (Fig. 2) and bathroom facilities. No booms of any significance had taken place since the time of redecoration.

Fig. 1 An old crack has opened up in the Station Chief's office at the ORC Station 6 months after redecoration.

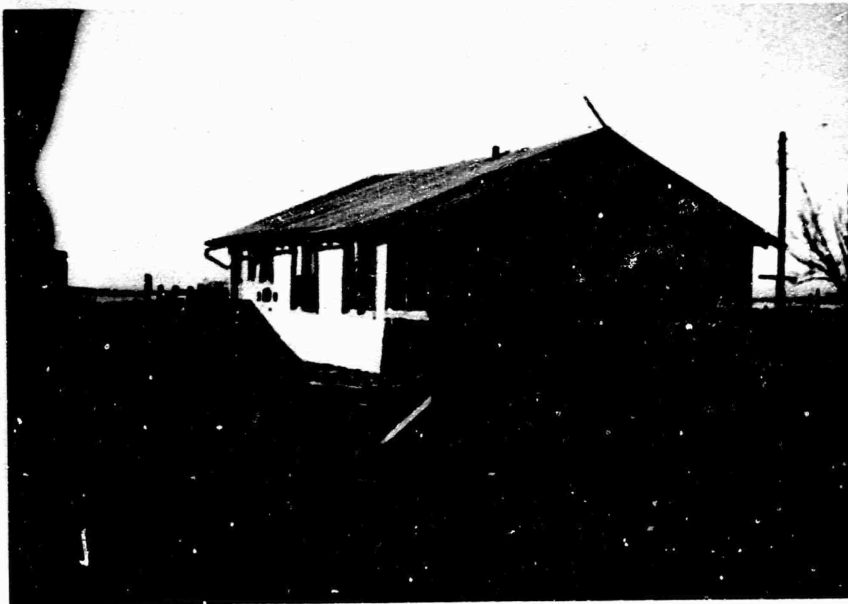
I visited the "Abandoned Ranch" shown in Figs. 3 and 4. Its condition is still bad with the additional glass damage. It was reported by Mr. Withers that the glass was broken by vandals some time earlier.

Fig. 3 "Abandoned Ranch" is still in bad condition. The windows were broken by vandals, as reported by Mr. Withers. All were new and unbroken at the beginning and end of the program.

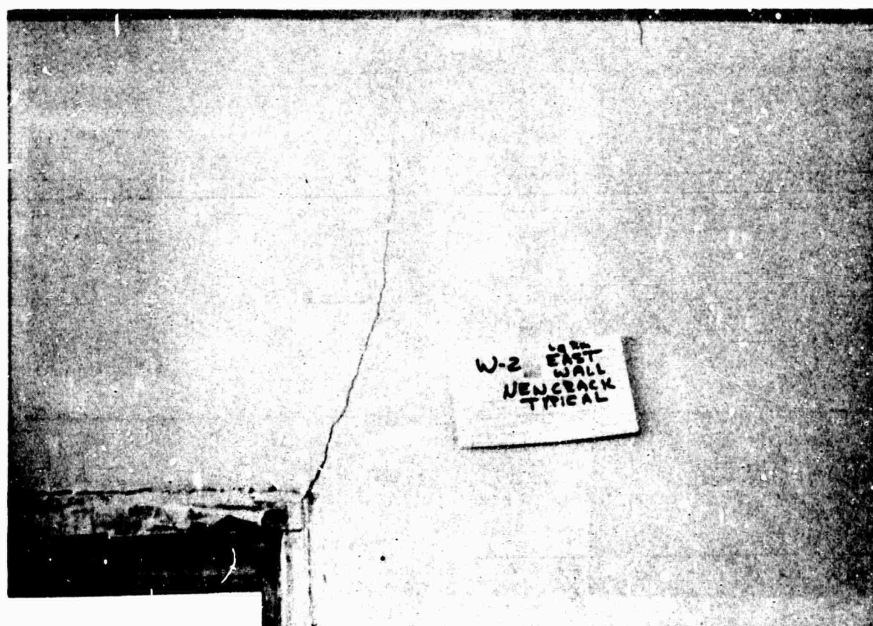
Fig. 20 W-2, Typical new crack

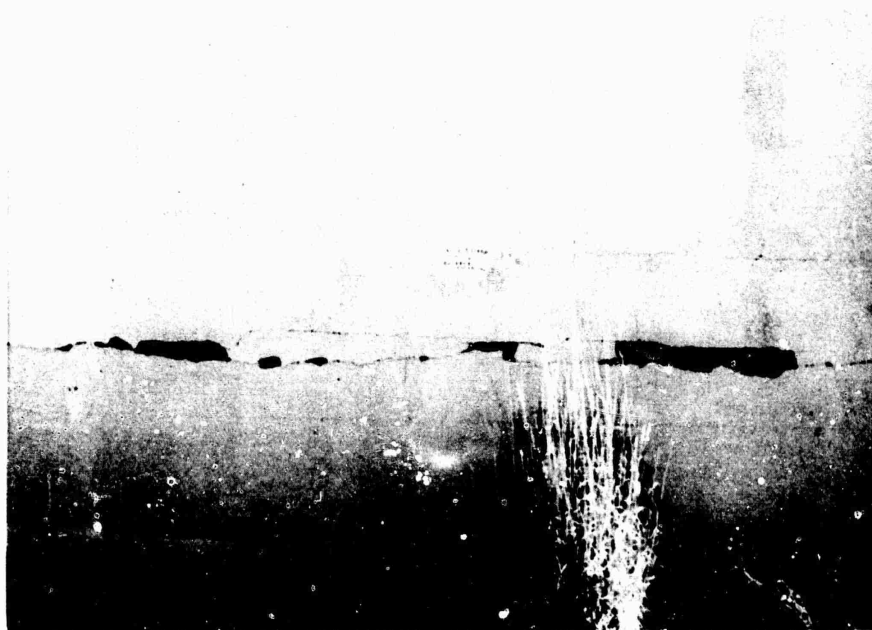
Fig. 25 W-3, Typical Exterior Damage

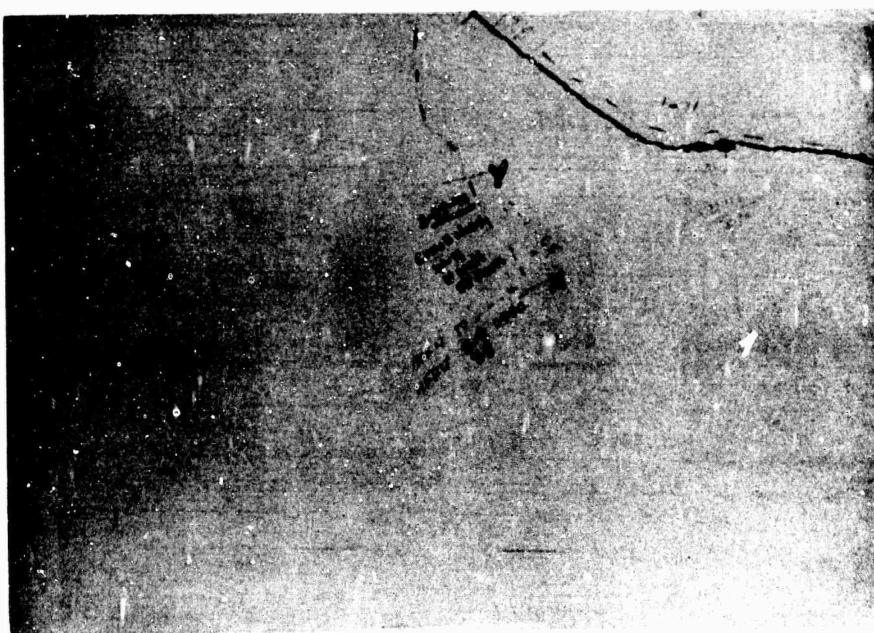
Fig. 32 W-4, Crack Which Had Opened to Point x
on 2-9-65, Had Closed to Point y on 2-25-72

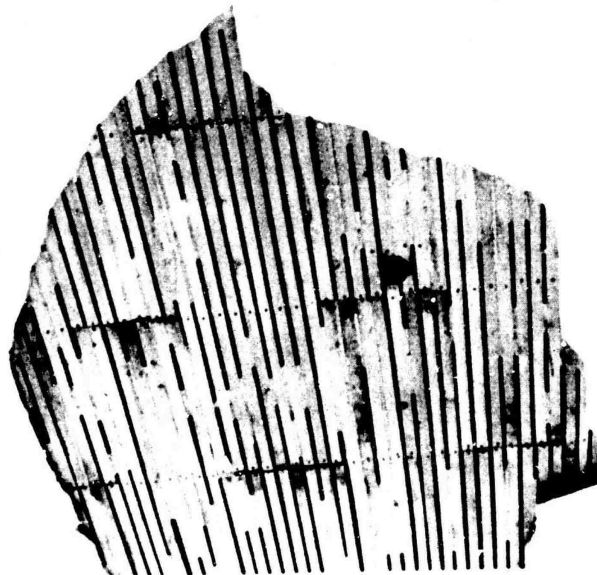
The upper living room ceiling in 2S-5 had collapsed and the second floor east wall had also been broken out about 2 inches. The brick work on the fireplace in 2S-5, however, was in absolutely perfect condition and suffered no damage during the last seven years. The wooden floors were quite weathered and some of the ceilings showed minimal leakage. There was some water damage in many of the buildings.

Fig. 38 2S-5, Fallen Ceiling in Second Story,
Plaster on Wood Lath

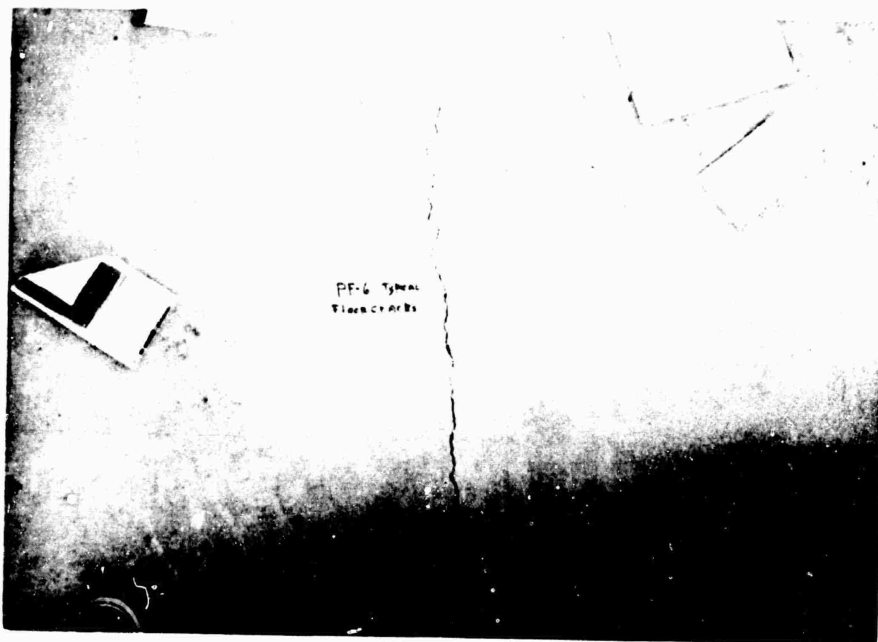
Fig. 47 PF-6, Floor Cracks in Building Not Found in C-1, W-2 due to Different Slab Design (See SST 65-15 (Vol. 2) Dwg B-3 and B-9).

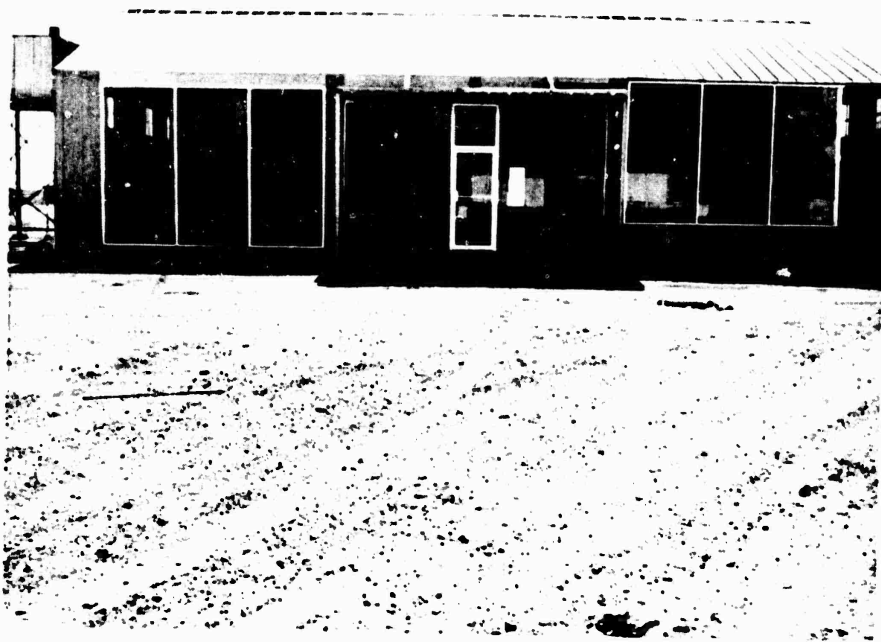
The Store-Front had two windows broken. The center solar gray glass (panel b) in the left three panels had broken. The mechanism of damage to the large window on the right

Fig. 48 Store Front, Window on Right and Solar pane on left are Broken

side of the Store-Front building did not look like sonic boom damage since it was highly localized in the top center portion of the frame. Using the techniques described by Wiggins* the probabilities computed for these two windows to be broken by sonic boom and not panels d and e leaves doubts as to sonic boom being the cause of damage.

These probabilities suggest that booms did not break the panes of glass. Further, since the broken panes were boarded up, panes d and e are considered to be the original panes used on the program and have not been replaced since 5-20-65.
